CONNECTICUT COASTAL BASIN
HAMDEN, CONNECTICUT

**FARM BROOK SITE 2B DAM
CT 01547**

**PHASE I INSPECTION REPORT
NATIONAL DAM INSPECTION PROGRAM**

SEPTEMBER 1981

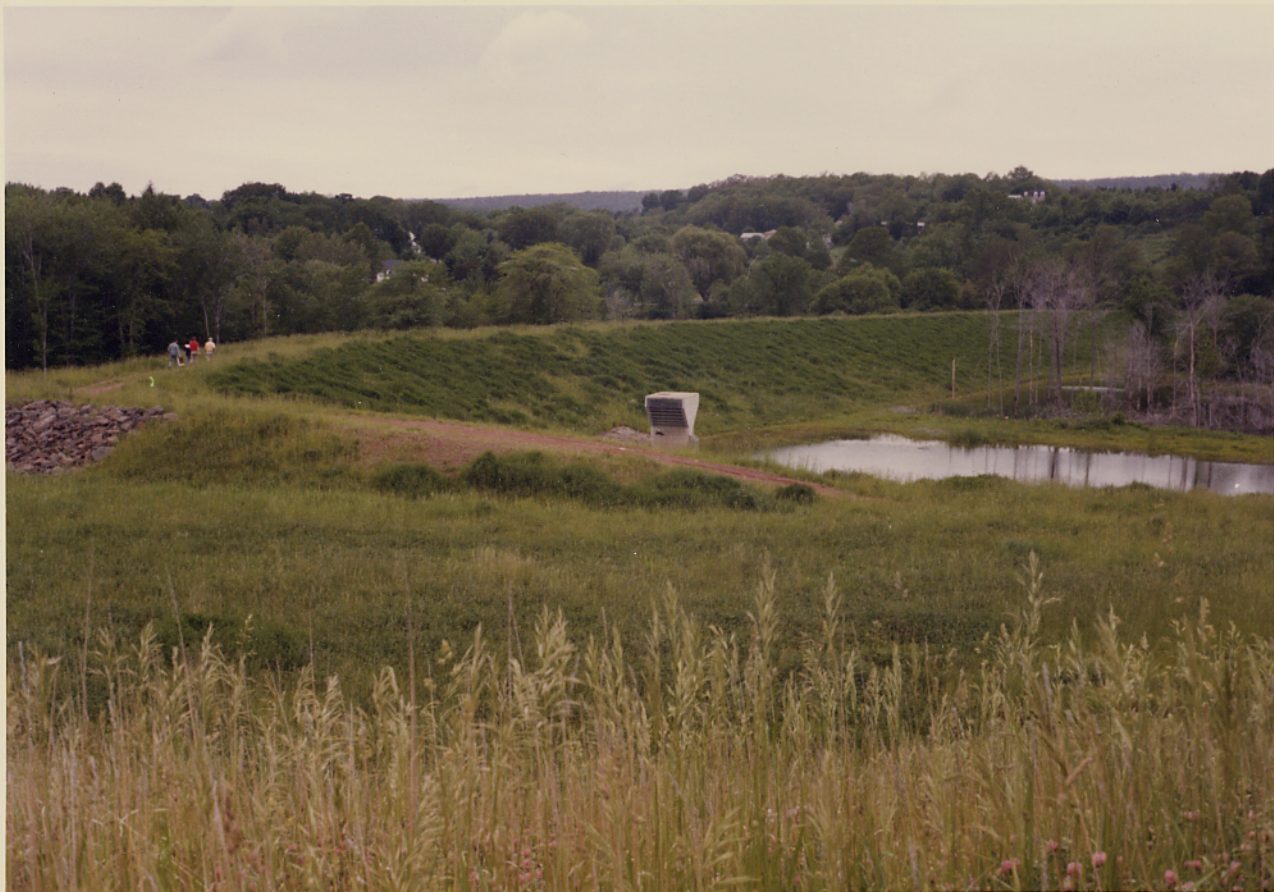
OVERVIEW PHOTO TAKEN JUNE 2, 1981.

Inspection of the downstream embankment slope and toe did not reveal any areas of seepage or sloughing. However, since the upstream pool elevation was only 3.5 feet higher than the downstream water level, a conclusive determination of the seepage conditions could not be completed. In addition, only one-half of the dam embankment was retaining water as shown in the Overview Photo.

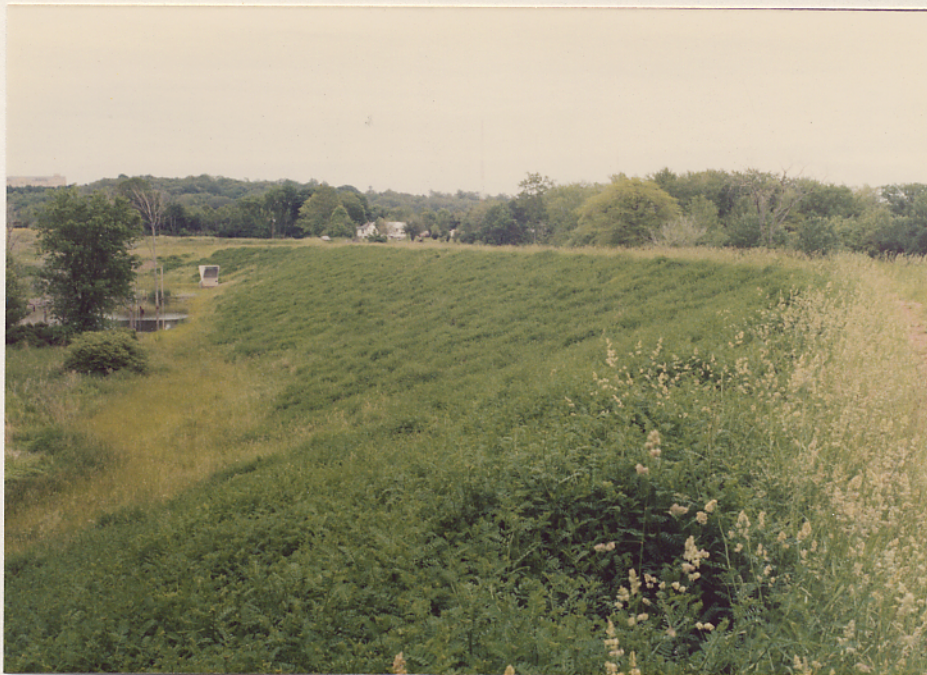
Farm Brook Site 2B Dam is an earthfill embankment with a foundation drain trench underlying the downstream slope. The vertical and horizontal alignment of the embankment appeared good with no indication of movement (see Photos 1, 2 & 3). Moderate rutting was observed along the crest of the dam as shown in Photo 2. In addition to these vehicular ruts, several areas of exposed earth with signs of minor erosion were noted on the crest. As indicated on the general plan in Appendix B, a narrow footpath was located on the downstream dam embankment. This trail was lacking vegetative cover and appeared to be slightly eroded. The embankment crest and slopes were covered with a stable growth of vetch with the exception of the

Photo 1 - View of upstream embankment
slope looking east

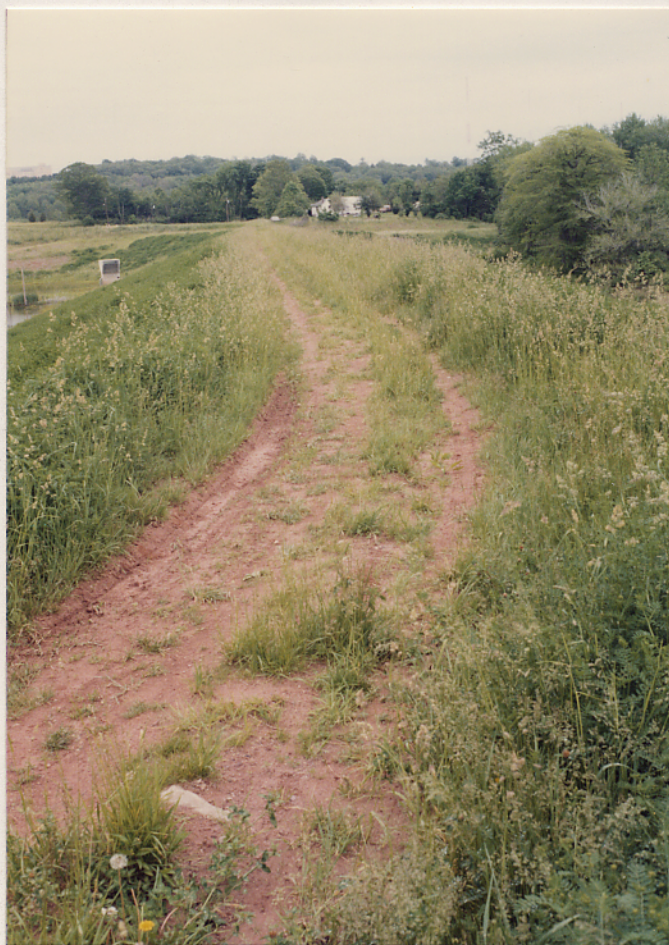
The visual inspection revealed no structural stability problems; however, three areas of concern were noted. Rutting and exposed earth areas resulting from vehicular trespassing were observed along the crest and/or slopes of the dam and spillway dike embankment. There was minor erosion associated with these areas which could diminish the embankment stability if not controlled.

Photo 2 - View of embankment crest looking
east. Note vehicular ruts.

6. Locate and, if required, clean out the 8" outlet pipe situated approximately 100 feet west of the noted footpath.
7. Repair concrete at foundation of fence post on concrete impact basin.
8. Remove brush and debris from the trash rack at the high orifice.
9. Remove sediment that has accumulated at the confluence of the downstream channel and the waterway.
10. Ensure the operability of the slide gate at the low level orifice on an annual basis.
11. Control access at project to discourage vehicular trespassing.

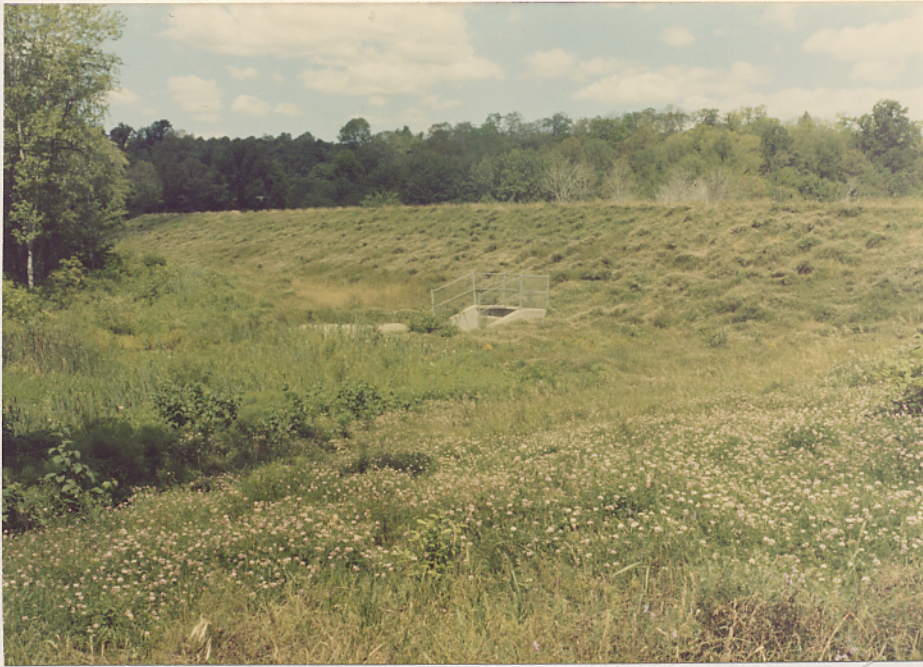
Photo 3 - Downstream embankment slope.
Note waterway status of dam.

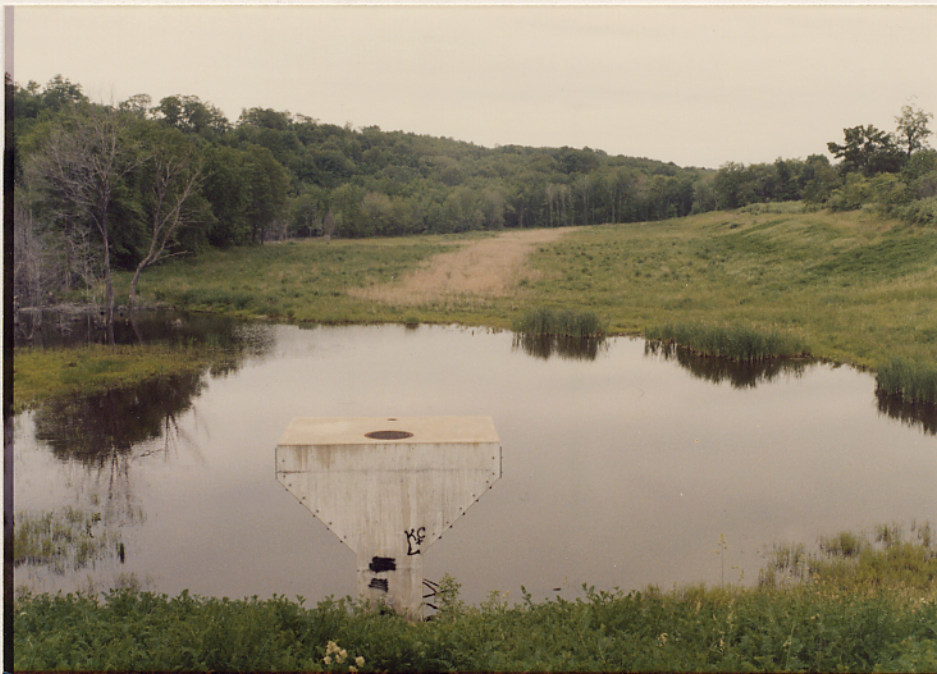
stormwater runoff passes under the dam embankment through the principal spillway. This reinforced concrete structure consists of a three stage intake riser, 30 inch pipe and impact basin. As shown in Photos 4 and 5, the intake riser was in good condition with no concrete cracking or spalling. Steel trash racks at the crest riser and high orifice were well painted and appeared to be structurally sound. Debris, such as tree branches and a small plywood board had accumulated at the high orifice level. Approximately 1' X 2', the plywood board was caught between the trash rack and concrete riser and could possibly obstruct flow to the orifice during high water conditions. The slide gate at the low orifice, which was not operated, was closed and fully submerged, preventing its inspection. Directly behind the intake riser, there is a grouted riprap area which is stable and in good condition (see Photo 4).

Photo 4 - Upstream reservoir area with
intake riser in foreground

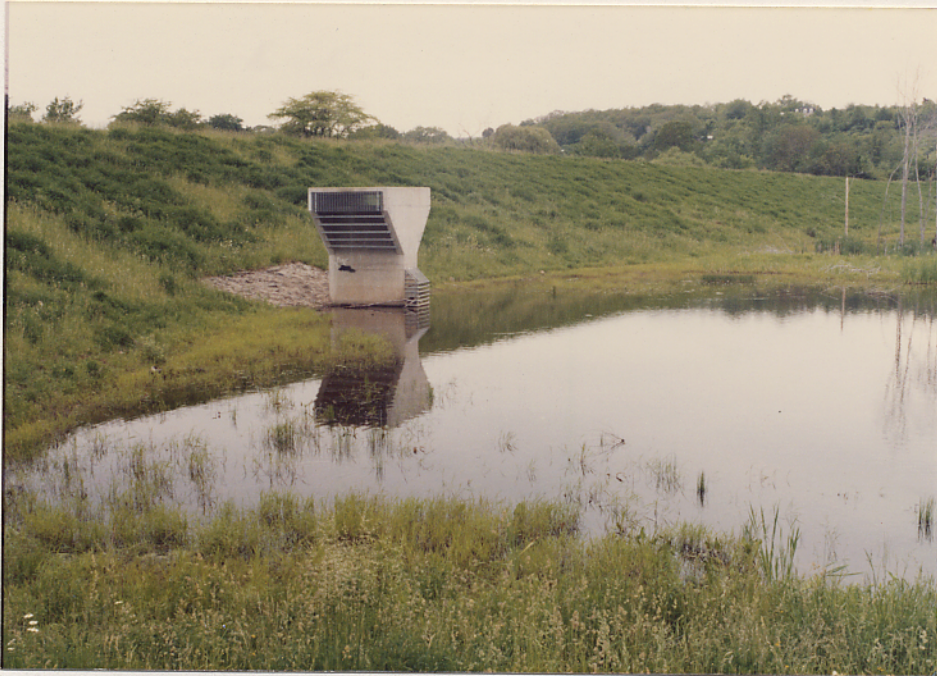
Photo 5 - Reinforced concrete intake riser. Note grouted riprap.

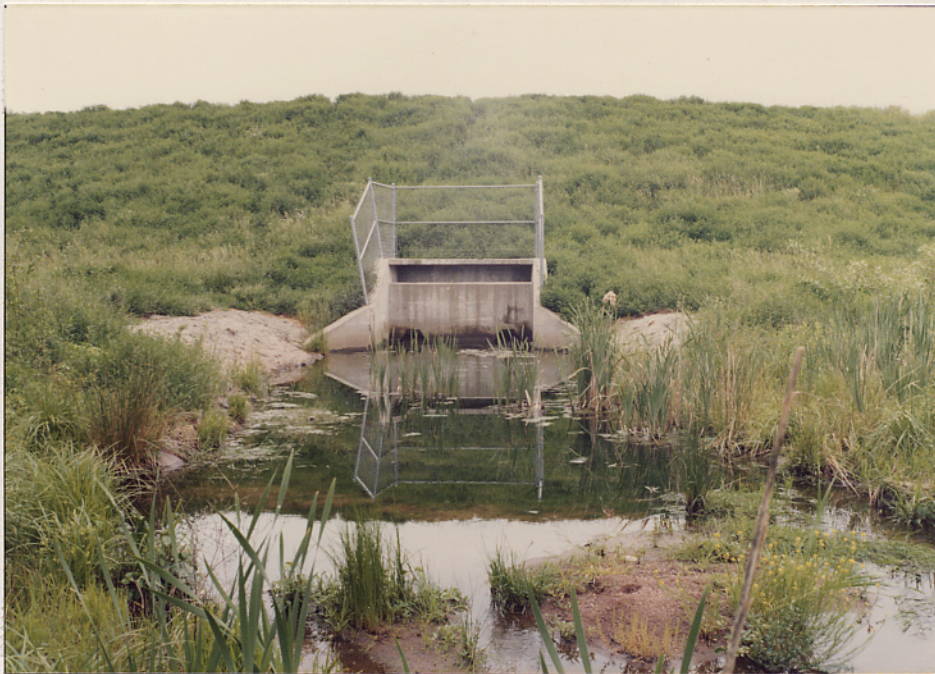
As shown in Photos 6 and 7, the reinforced concrete impact basin is in good condition. There was no visible cracking or spalling with the exception of the broken concrete at the base of two fence posts. The west section of the chain linked fence is tilted resulting from the deteriorated concrete condition. Immediately downstream of the impact basin is a riprapped area of which the first 23 feet is grouted and in good condition. The 44 ft. non-grouted riprapped section was also stable, but overgrown with weeds.

Photo 6 - Reinforced concrete impact basin. Note tilted chain linked fence.

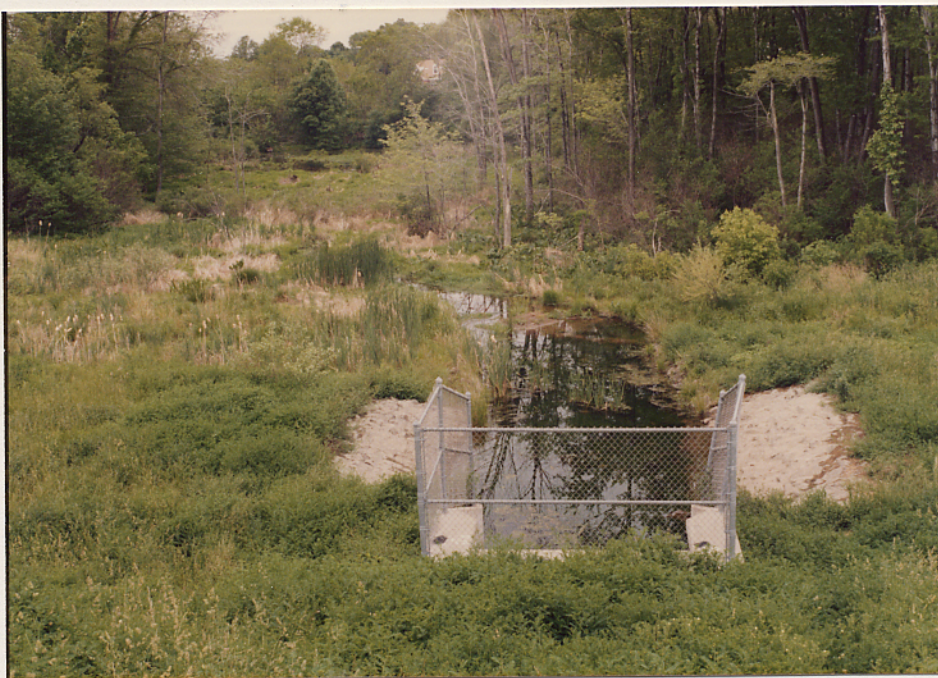
The channel downstream from the impact basin is generally open with no build-up of brush or debris. Minor weed growth was noted in the channel and along its slopes as shown in Photo 7. At the confluence of the downstream waterway, sediment has accumulated, which is partially obstructing

Photo 7 - Downstream Channel

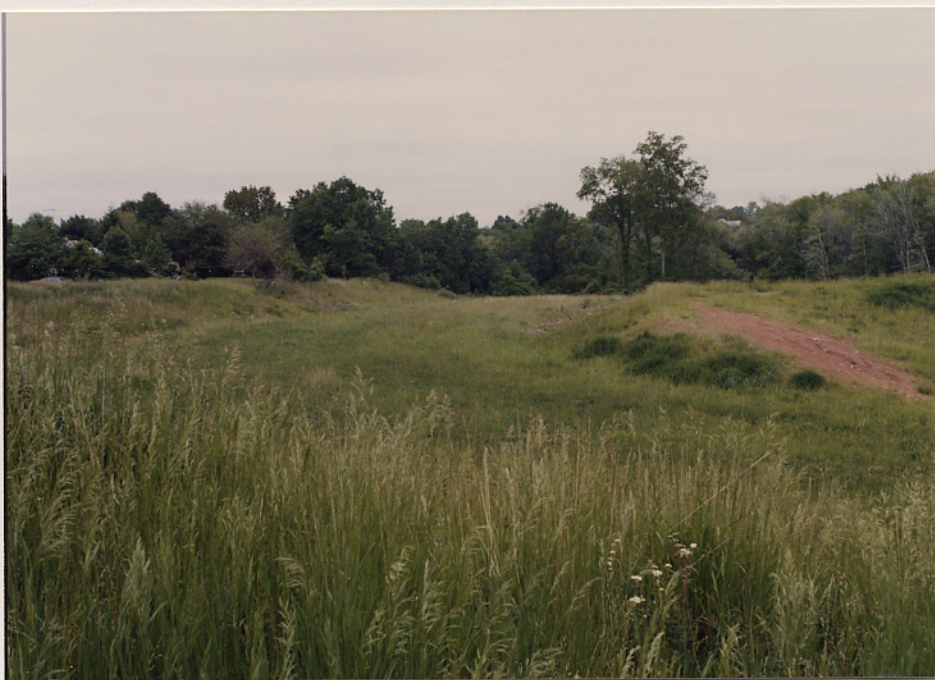
as shown in Photo 8. Riprapped areas along this cut slope and the rock lined diversion, north of the spillway appeared stable with no signs of failure. Groundwater seepage under the spillway approach channel is controlled by a drain trench as indicated on the general plan in Appendix B. The drain trench outlets through a 10" corrugated metal pipe onto a riprapped area. With animal guards in place, the pipe was dry and clean with the riprapped area remaining stable.

Along the west side of the spillway is an earthfill dike which is protected from scouring by a stable riprapped slope. Exposed earth was observed on the grass covered crest and west embankment slope of the dike. Minor slope erosion associated with the bare earthen areas was noted at the north end of the dike as shown in Photo 8.

Photo 8 - View of emergency spillway
looking south. Note eroded area
on crest of dike.
